Aviation Safety

Maintainer

Issue 3/2003

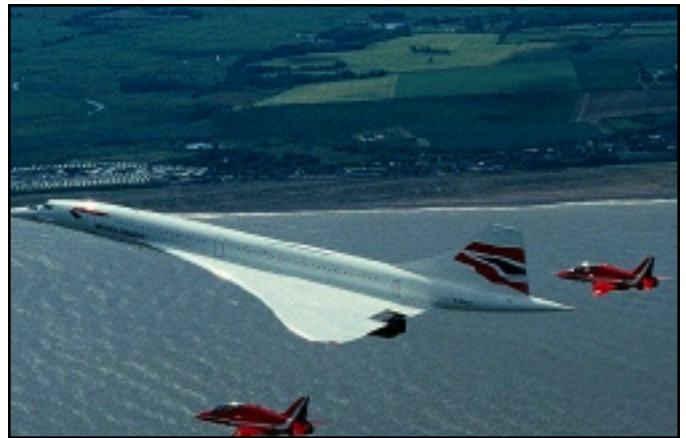
The Concorde took off on a flight from Paris, France to New York, USA, on July 25, 2000. During the take-off roll, and just before rotation, a front right landing gear tire ran over a strip of metal and was damaged. It burst into several pieces and debris was projected against the left wing fuel tank No. 5 outboard skin, which ruptured and sent fuel that ignited immediately as it came in contact with hot exhaust gases from the engines. The No. 1 and No. 2 engines lost power and No. 2 was shut down. The No. 1 engine was operated briefly at idle power due to a fire warning alarm, and the aircraft took off as it was too far into its take-off run. The landing gear would not retract because of hydraulics failure and the aircraft could not gain height or speed. It flew for about 1 min when the No. 1 engine lost power, the angle of attack and angle of bank increased, the No. 3 and No. 4 engines lost power and the Concorde, uncontrollable at this point was lost.

The French civil aviation investigation bureau, the *Bureau d'enquêtes et d'analyses pour la sécurité de l'aviation civile* (BEA), found that during the take-off phase, the tire on wheel No. 2 was cut by a metallic strip on the runway. The part came from the thrust reverser cowl door of engine No. 3 on a DC-10 that had taken off 5 min before the Concorde. It had been replaced twice in the last two months; once in June and once in July of 2000. The second time that it was replaced, it had neither been manufactured nor installed in accordance with procedures defined by the manufacturer. "The loss of the wear strip from the thrust reverser door on the Continental Airlines DC-10 originated from a lack of rigorous maintenance. The part was not in accordance with the manufacturers specifications. Of course, this is not a critical part from an airworthiness perspective, but true safety implies strict respect for procedures, without any personal interpretation. Facts established concerning the metallic strip and the aircraft reveal inadequate adherence to maintenance procedures by the various workshops that carried out the work on the reverse cowl." (BEA)

In order to return the Concorde to service, the BEA recommended that a flexible fuel tank liner be installed to reduce the risk of fuel leak following damage, and the possibility of a shock wave that

could induce fuel instability and fuel tank rupture. It also recommended the installation of new reinforced Michelin tires that would have improved impact resistance qualities. There were modifications made to the landing gear water deflectors and reinforcements made to the wiring of the main undercarriage area. It further recommended that operators adopt a feedback process, SMS*, that would provide through analysis of in-service accidents, a process to identify and rectify safety issues before they could ever become an accident with tragic consequences. Several Concorde had sustained tire failures, and fuel tank damage due to impact from tire or foreign object damage (FOD) debris prior to July 25, 2000.

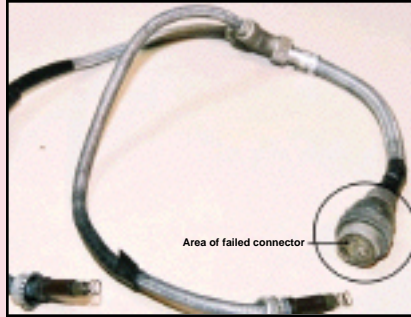
A float-equipped DHC-2 was cruising at an altitude of 1 500 ft enroute from Campbell River, B.C. when the engine failed and would not restart. The

pilot set the aircraft up for a glide and proceeded to land uneventfully close to a marina near Seymour Narrows, B.C. The aircraft was soon towed to a safe moorage where the pilot and passengers were able to exit the plane and return home. Close examination of the engine revealed that the engine stoppage was due to a failure of the dual magneto cable connector lug at the firewall. This part, identified as SKL3-21-3-8AN, has an internal safety mechanism that disables both magnetos to preclude inadvertent start of the engine when the magneto electrical harness is disconnected from the firewall for maintenance.

When the unit functions properly and the lug is connected, a male mating pin lifts a shorting strap out of the way and removes the ground from the magneto “P” leads, allowing control of the magnetos through the cockpit magneto selector switch. If this pin fails, it may allow the shorting strap to ground the mags and the engine malfunctions. This type of

connector receptacle only seems to be common to the DHC-2 and -3. The connector is an “on condition” component and as it ages, the risk for malfunction increases. There is no practical test to determine its condition. Aircraft maintenance engineers (AME) working on these types of aircraft may not be aware of the presence of such a mechanism and may find, through a continuity check that the magneto leads are all right when in fact, this grounding strap may be about to fail. The maintenance manuals for both of these aircraft as well as the Service Bulletin and Service Letter index make no mention of such unit maintenance requirements as they are operated to failure, then replaced.

In another similar case of engine failure, the Otter engine failed because the magneto connector lug at the firewall loosened and let go, allowing the internal connector grounding strap to function and stop the engine. Investigation revealed that the magneto connector lug secured by a lock wire had failed because the lug collar hole had broken open and allowed the lock wire to slip away and the connector to become undone. De Havilland Alert Service Letter A2/53 makes reference to this mode of failure and a check of the state of these important features on the connector lugs will prevent the reoccurrence of such mishaps. Bombardier/DeHavilland, recommends that this inspection be carried out at the earliest opportunity. Beware! 🛠️
